**Helen Bebout**  
**2072 Maple Ave**  
**Ballston Lake, NY 12019**  
**HIN™:** 120194020  
**Email:** [tbird485@yahoo.com](mailto:tbird485@yahoo.com)  
**Inspection Date:** 09-01-2020

**Focus on Homes Inspections**  
**Steve Theiss**  
**37 Cherry Tree Lane**  
**Wilton, NY 12831**  
**Phone:** (518) 581-7537  
**E-Mail:** [steve@focusonhomes.com](mailto:steve@focusonhomes.com)

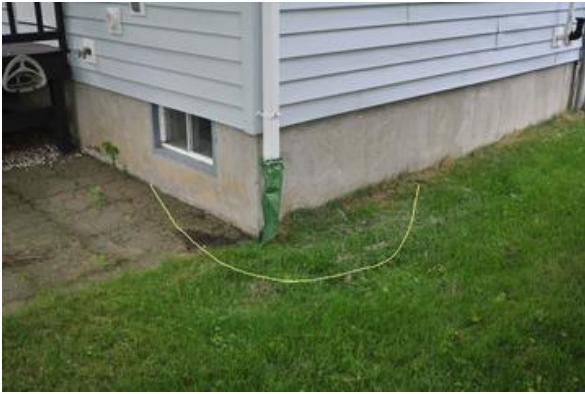
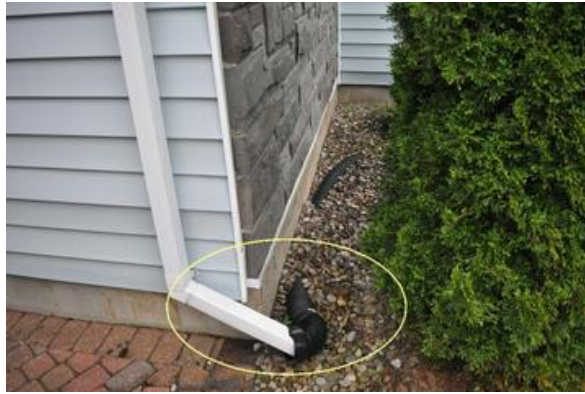
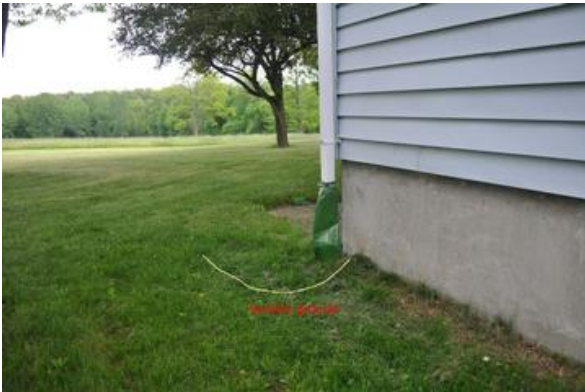
06/08/2020 Gutters had extensions, but they were not long enough to get water away from the foundation. Recommend a qualified contractor install gutter extensions that are at least 6 ft. away from foundation wall.

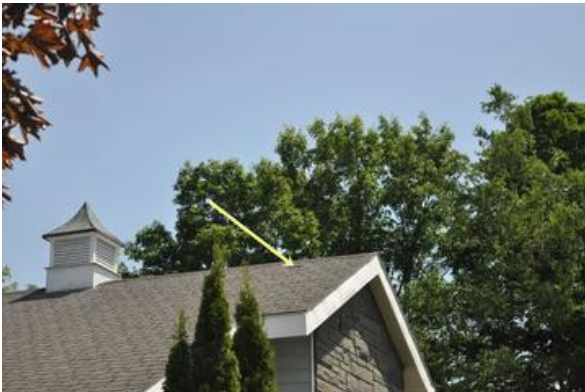
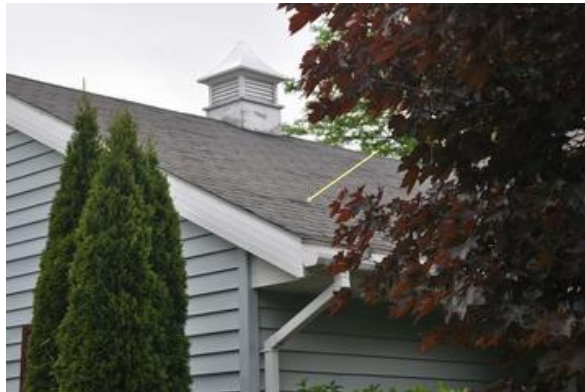
06/09/2020 Noted missing tiles on roof. This can cause water infiltration. Recommend remediation by a qualified contractor.

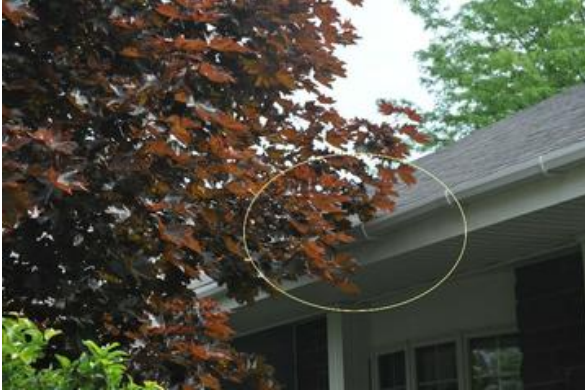
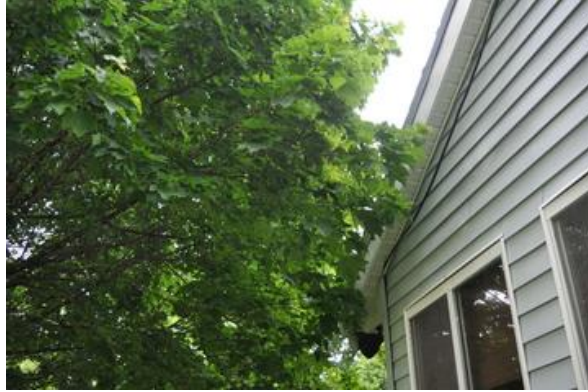
06/08/2020 Trees are overhanging roof and are within 10 feet of roof vertically. Recommend pruning trees so they're at least 10 feet above roof, or don't overhang the roof.

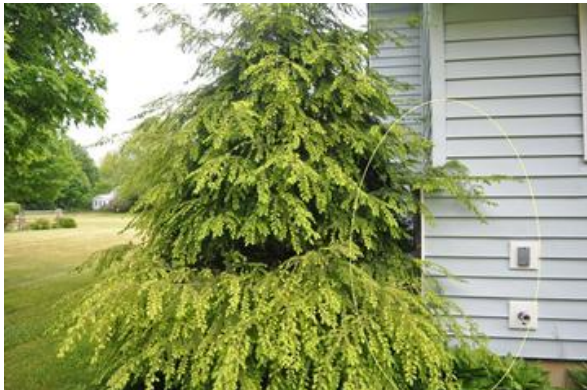
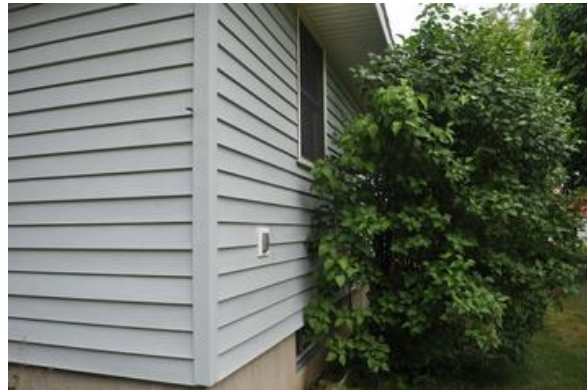
06/08/2020 Shrubs are in contact with siding. Recommend pruning or moving shrubs so there's at least a one foot gap between shrubs and siding.

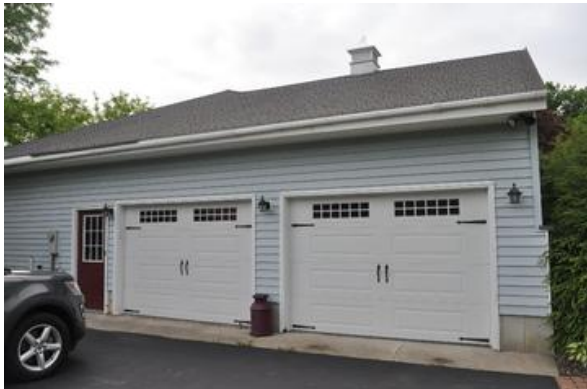
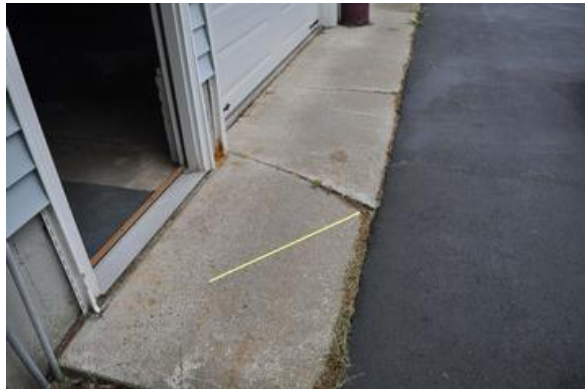
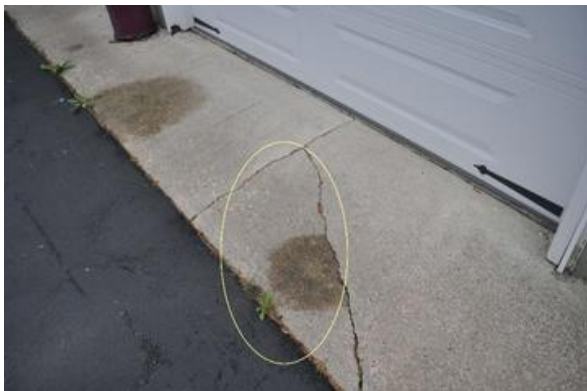
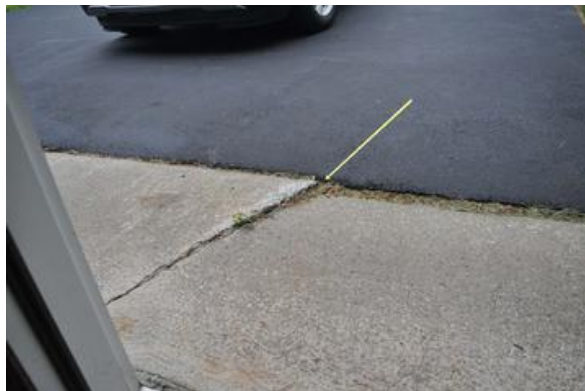
06/08/2020 Concrete ramp into the garage was cracked and heaved, possible tripping hazards causing injury. Recommend a qualified contractor repair.

Concrete ramp into the garage was cracked and heaved, possible tripping hazards causing injury. Recommend a qualified contractor repair.

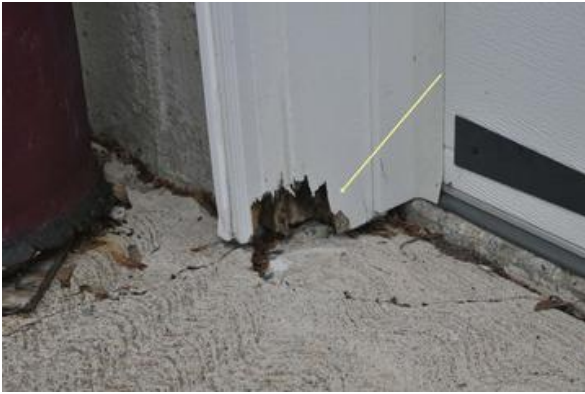
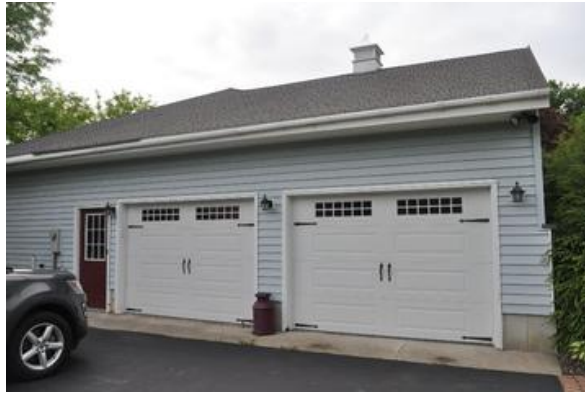
06/08/2020 Rotting of the garage door trim and frame. This can lead to intrusion into the home by insects and critters. Recommend repair by a qualified contractor.

Rotting of the garage door trim and frame. This can lead to intrusion into the home by insects and critters. Recommend repair by a qualified contractor.

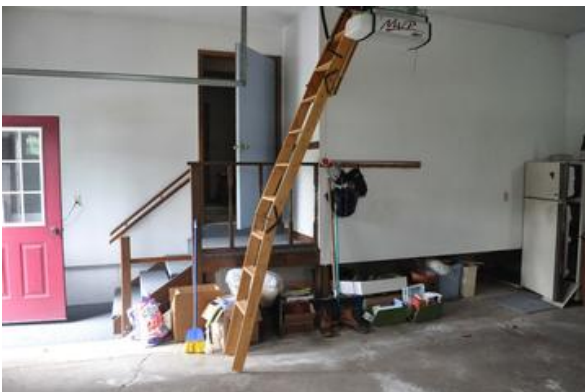
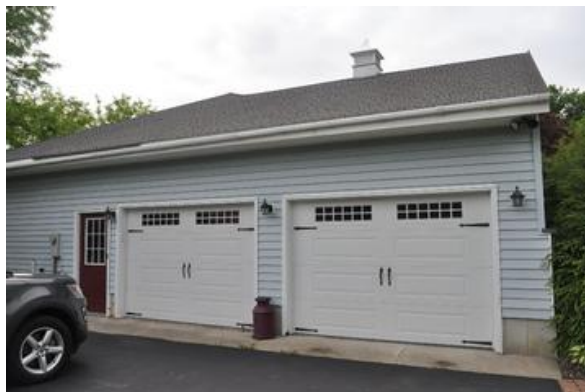
06/08/2020

Noted attic pull down stairs stringers are too short which could cause injury when traversing the stairs. This could lead to stair failure when being used which could cause personal injury. Recommend a qualified person extend stringers to correct the issue.

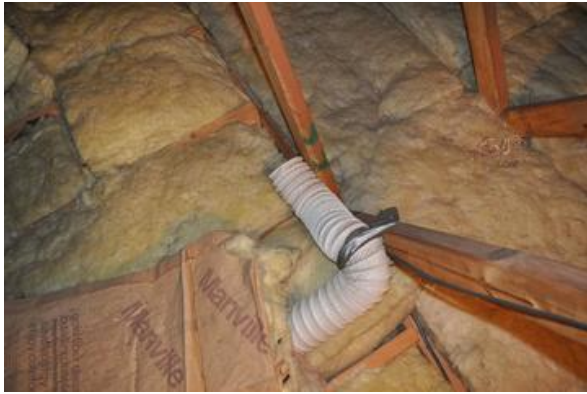
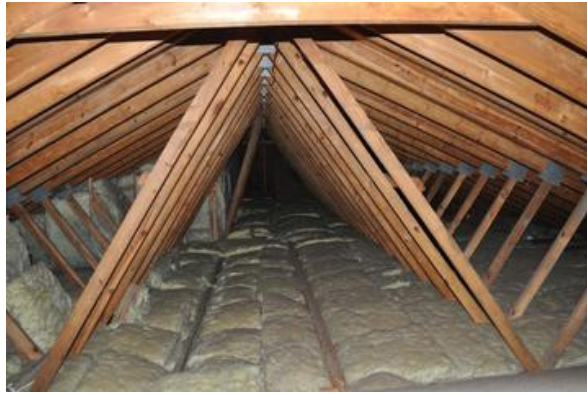
06/08/2020 Exhaust fan terminates in attic. Venting into the attic puts extra moisture in the attic which may lead to mold accumulation. Recommend installing a duct with minimum R8 insulation and vent either thru the roof or to a soffit, by a qualified contractor.

Exhaust fan terminates in attic. Venting into the attic puts extra moisture in the attic which may lead to mold accumulation. Recommend installing a duct with minimum R8 insulation and vent either thru the roof or to a soffit, by a qualified contractor.

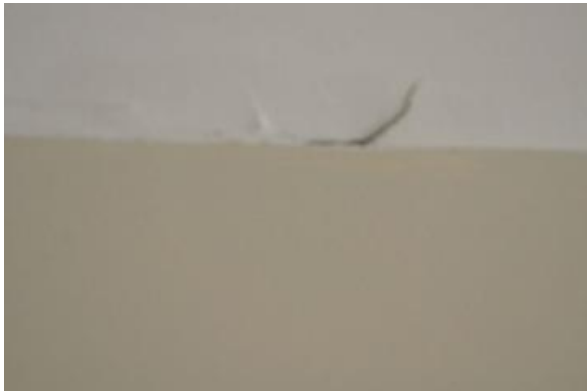
06/08/2020 Overall condition of the drywall was good there was minor nails pops throughout the house

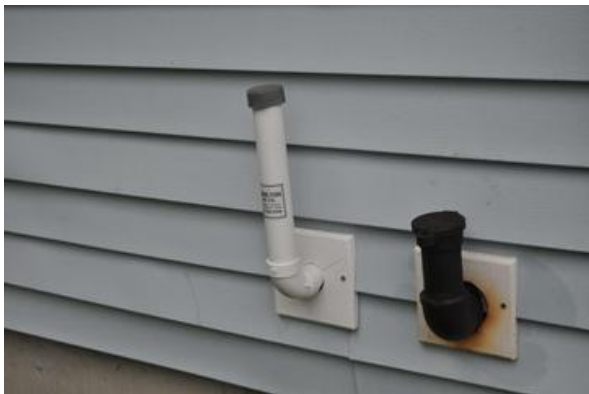
06/08/2020 Oil tank vent pipe is PVC which can deteriorate from oil fumes and then fumes enter the home. Recommend a qualified contractor replace with steel piping.

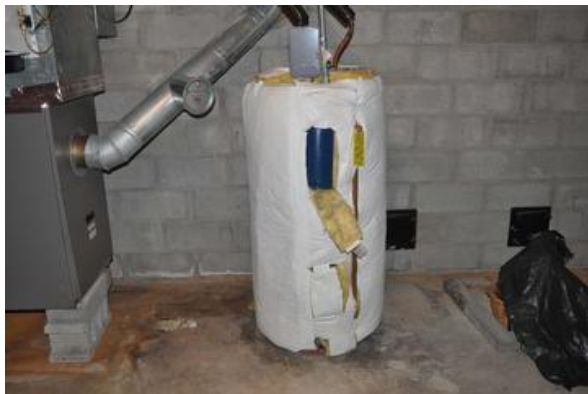
06/09/2020 Unit was wrapped in insulation. This made it impossible to determine the age or make. Unit operated as designed at time of inspection. Recommend flushing the unit out every 2 years

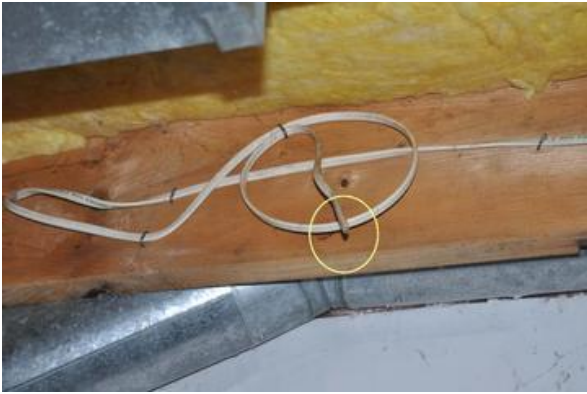
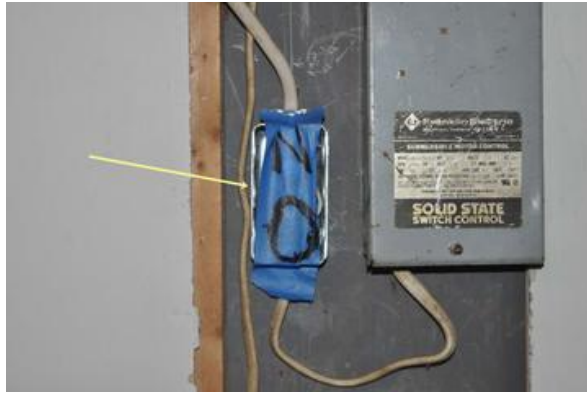
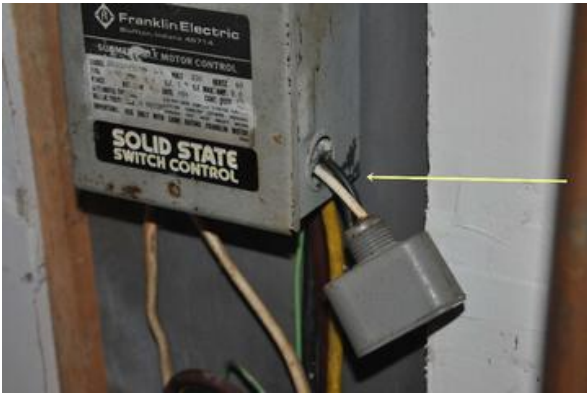
06/08/2020 Missing box cover and un-terminated wire which will allow someone to accidentally be shocked or electrocuted if contacted. Recommend repair by a qualified electrician.

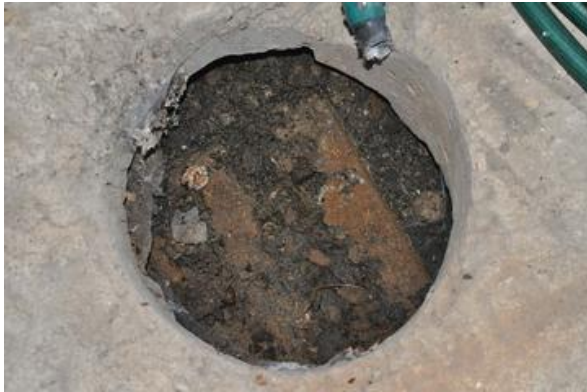
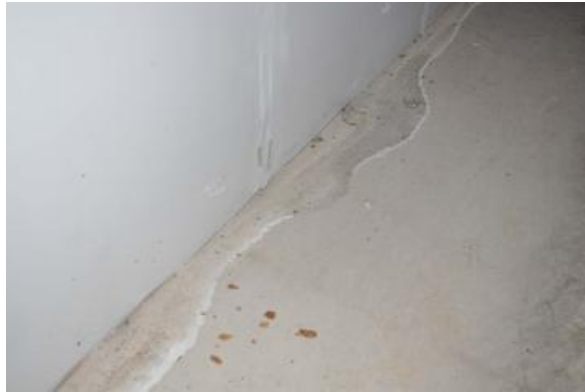
Sump hole

06/08/2020 No water present in the sump hole. Some beginning signs of moisture on basement floor. No gutters were on the back the house water from the roof can accumulate near the foundation creating possible problems. Recommend gutters be installed on the back of the house to keep water away from foundation.

No water present in the sump hole. Some beginning signs of moisture on basement floor. No gutters were on the back the house water from the roof can accumulate near the foundation creating possible problems. Recommend gutters be installed on the back of the house to keep water away from foundation.
